In September 2010, the Insurance Institute for Business & Home Safety (IBHS) conducted a full-scale beta test at its multi-peril Research Center in South Carolina as part of the laboratory commissioning process. For the beta test of IBHS' ability to realistically recreate a variety of windstorms, two identical looking, 1,300 square foot, two-story homes were placed side by side in the test chamber and subjected to sustained wind and gusts which peaked at 96 mph. One test house was built using conventional construction standards common in the Midwestern U.S., and the other house will be built to IBHS' code-plus FORTIFIED for Safer Living® superior construction standards as they would apply in that same area of the country. The houses were built off of blueprints/plans for a real FORTIFIED home in Bloomington, Ill.

# FORTIFIED for Safer Living® vs. Conventional Construction

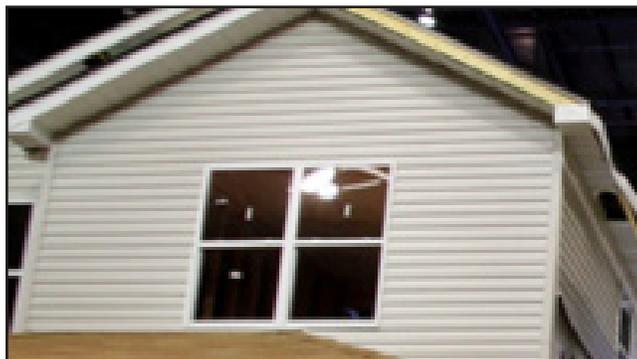
## Standard Building Code Home

**SC Farm Bureau: \$5691.73**  
**State Farm: \$6,913.50**

Of particular note is the MAGNITUDE of the difference between the cost to repair the FORTIFIED for Safer Living® home and the conventionally constructed house. The South Carolina Farm Bureau loss estimate for the conventional house is nearly eight times the loss estimate for the FORTIFIED house. The State Farm estimate for the conventionally constructed house was more than two times the loss estimate for the FORTIFIED house. This puts the average of the two loss estimates at roughly five to one. Had these houses been fully finished on the interior and furnished, the damage ratio would be much, much higher for the conventionally constructed house.

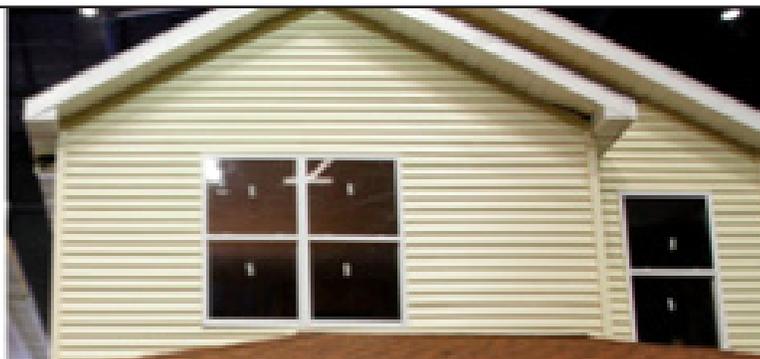
## IBHS FORTIFIED for Safer Living® Home

**SC Farm Bureau: \$743.12**  
**State Farm: \$2,975.14**

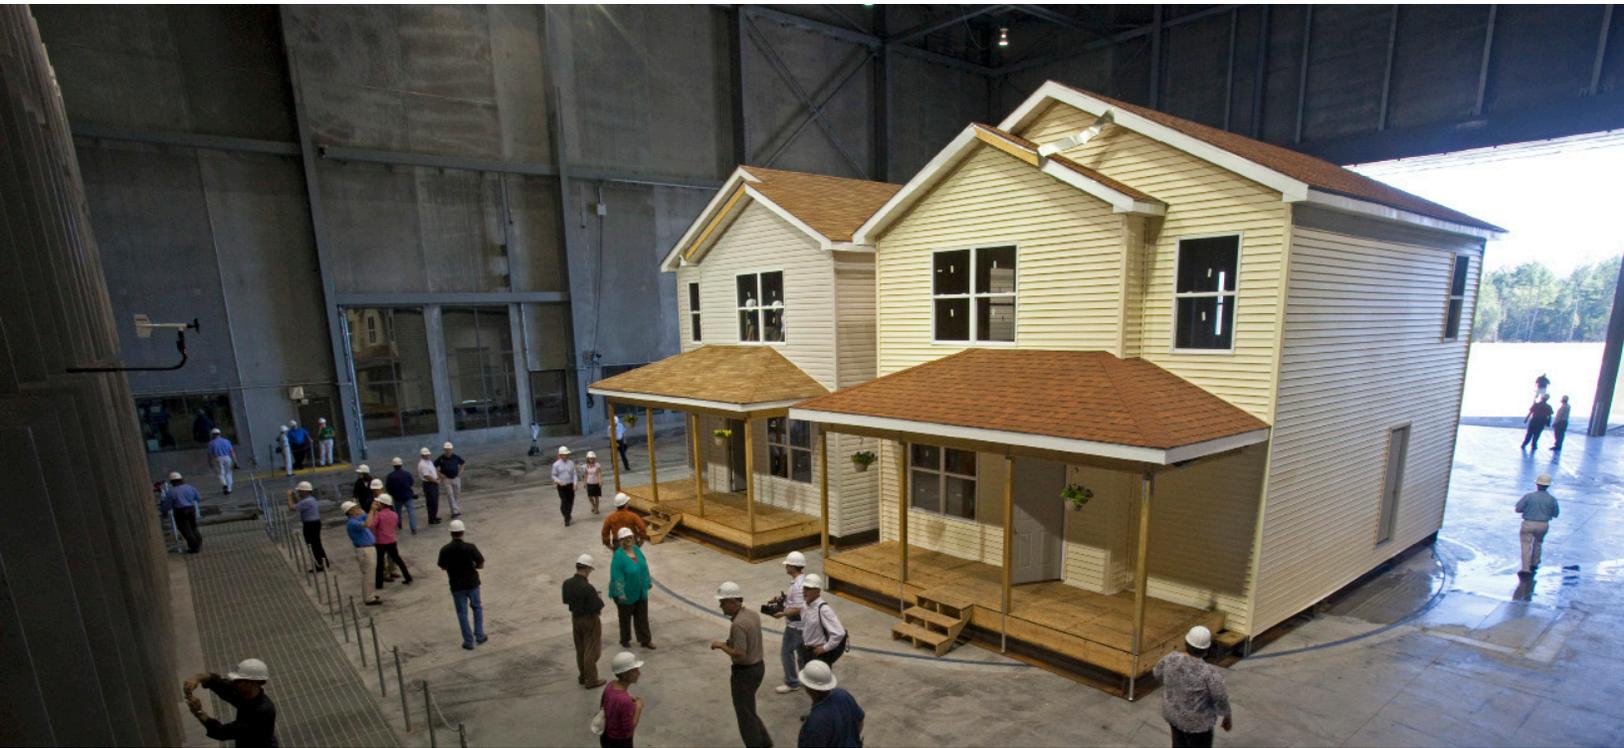
*Home built to conventional Midwest construction standards (L) and home built to IBHS FORTIFIED for Safer Living® standards (R) in IBHS Research Center test chamber.*

The specimen houses featured in the October 2010 thunderstorm demonstration test essentially replicated an actual home built in central Illinois. One copy of the Bloomington house was built using conventional construction techniques common in that part of the country, while the other was built to the IBHS FORTIFIED for Safer Living® standards designed for Midwestern construction.

To make the FORTIFIED house more resilient to the types of severe weather events prevalent in central Illinois (e.g., thunderstorms, tornadoes, and winter storms), it has the following features, which the conventionally constructed home does not:

- Straps that tie the roof to the walls, the top floor walls to the bottom floor walls, and the bottom floor walls to the foundation;
- High wind-rated siding;
- High wind-rated roof covering;
- A front door that opens out instead of in;
- 8d ring shank nails, instead of staples to significantly strengthen the connection of roof and wall structural members;
- A secondary water barrier on the roof; and,
- 5/8-inch plywood roof decking, instead of 1/2-inch decking.
